MOTORCYCLE SERVICE NEWS

259

DATE 1-15-71

SPACING TRANSMISSION AXLES AND GEARS - continued

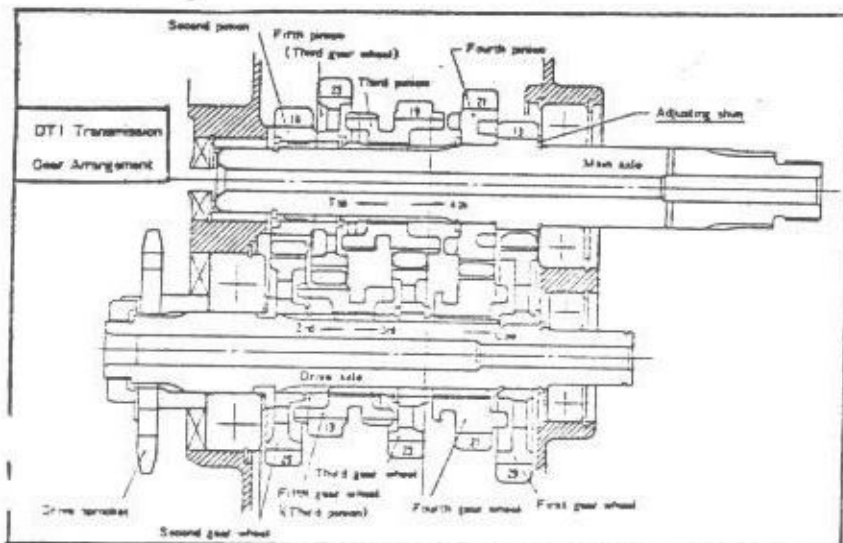
IMPORTANT; PROPER SHIFT DRUM SPACING: Some models have shift drums anchored at one end with half-moon shift drum holders and a circlip (such models as G6, HT1, CT1, etc.). The shift drum is properly spaced by placing a spacer (#15 in Fig. #5) directly behind the half-moon holders, on the outside of the crankcase. If the spacer is placed inside the case, against the shift drum shoulder, the drum will be spaced too far toward the right. This will pull the shift forks to the right, causing incomplete gear engagement.
